Repair Manual Supplement: Vehicle Pulling to One Side

Service Category Steering

Section Steering Gear/Linkage

TSIB SUPERSESSION NOTICE

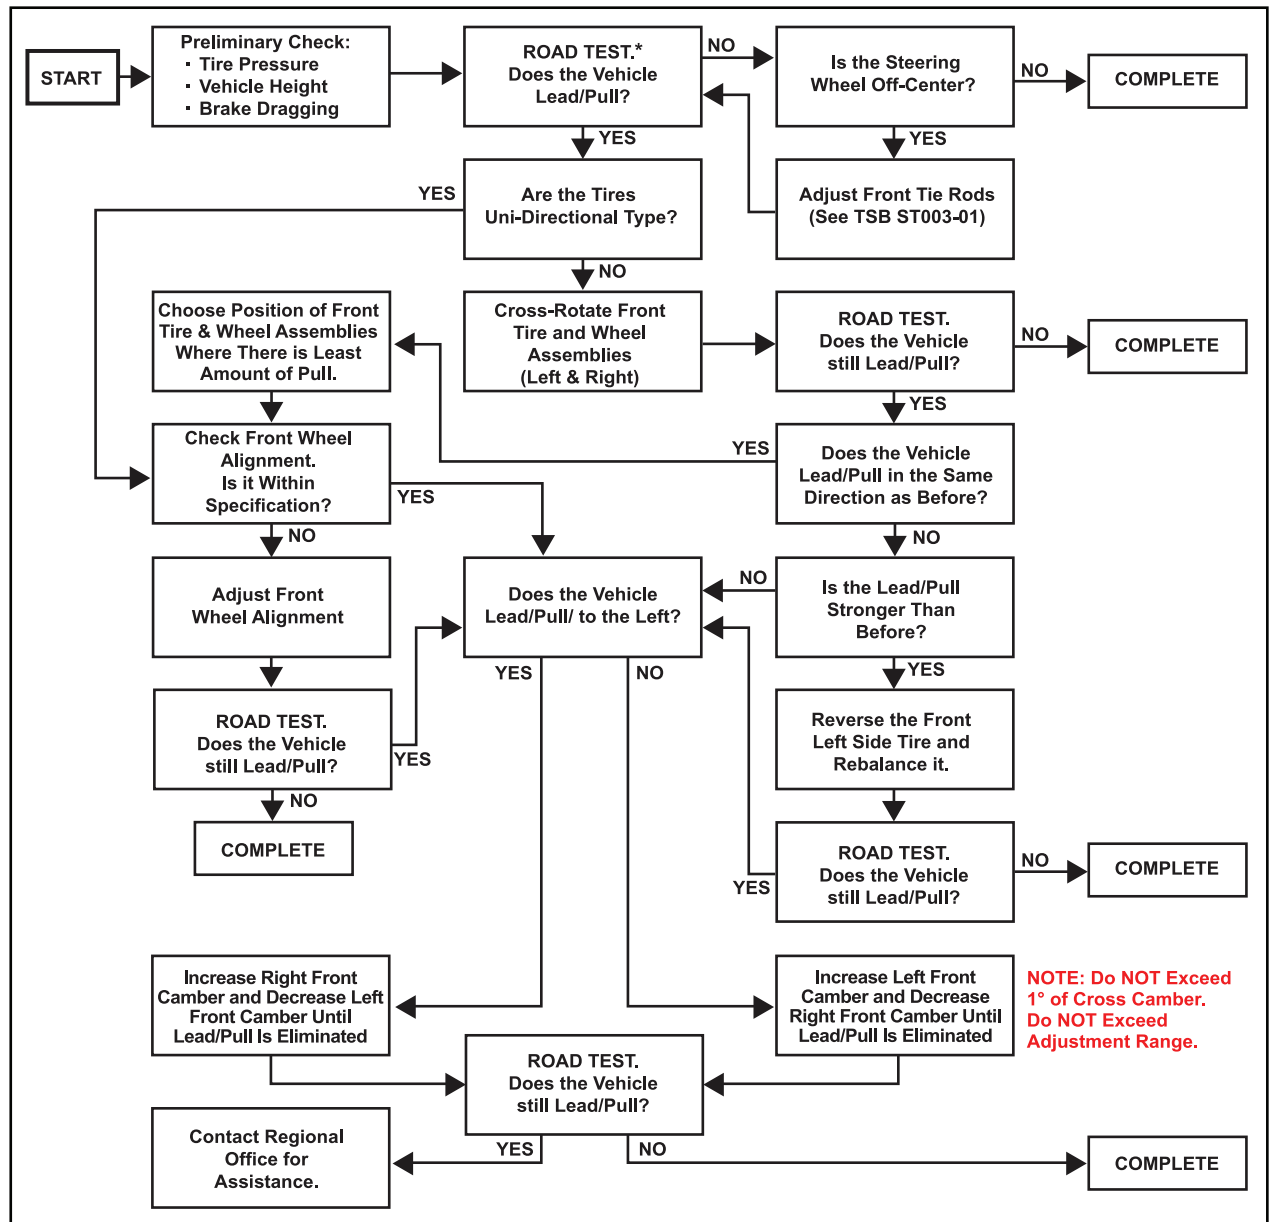
Figure 5.

- Steering Off Center: The vehicle goes straight but the steering wheel has some angle.
- Steering Pull: The vehicle does NOT go straight.

* Select a flat road where the vehicle can be driven in a straight line for 109 yards (100 meters) at a constant speed of 35 mph (56 km/h). Please confirm safety and set the steering wheel to its straight position. Drive the vehicle in a straight line for 109 yards (100 meters) at a constant speed of 35 mph (56 km/h) without exerting steering effort on the steering wheel.
