Center Console Wood Grain Panel Cracked

Service Category Vehicle Interior

Section Interior Panels/Trim

Some 2007-2011 model year LS 460/460L/600hL vehicles may exhibit a “crack” in the clear coat of wood trimmed center console components. Updated center console components are now available for Medium Brown Walnut and Matte Dark Brown Ash Burl colored panels.

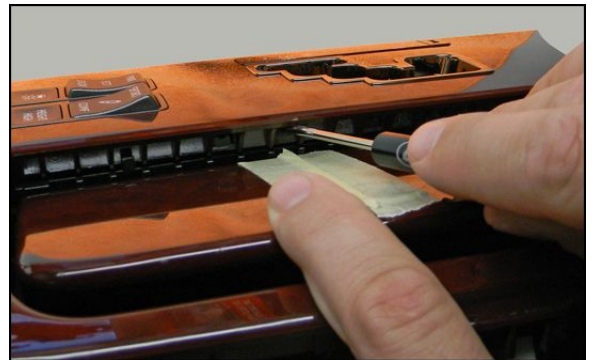
Figure 5.

- D. Open the Instrument Panel Cup Holder Cover half-way to expose the plastic retention claw and using a small flathead screwdriver or similar tool, disengage the claw.

- 5. Install the NEW front center console component(s) and reassemble the front console box. Refer to TIS, applicable model and model year Repair Manual.
