Technical Service Information Bulletin

AUDIO DOOR OPENING/CLOSING EFFORT IMPROVEMENTS

'02 – '05 SC 430

BODY
B0001-05

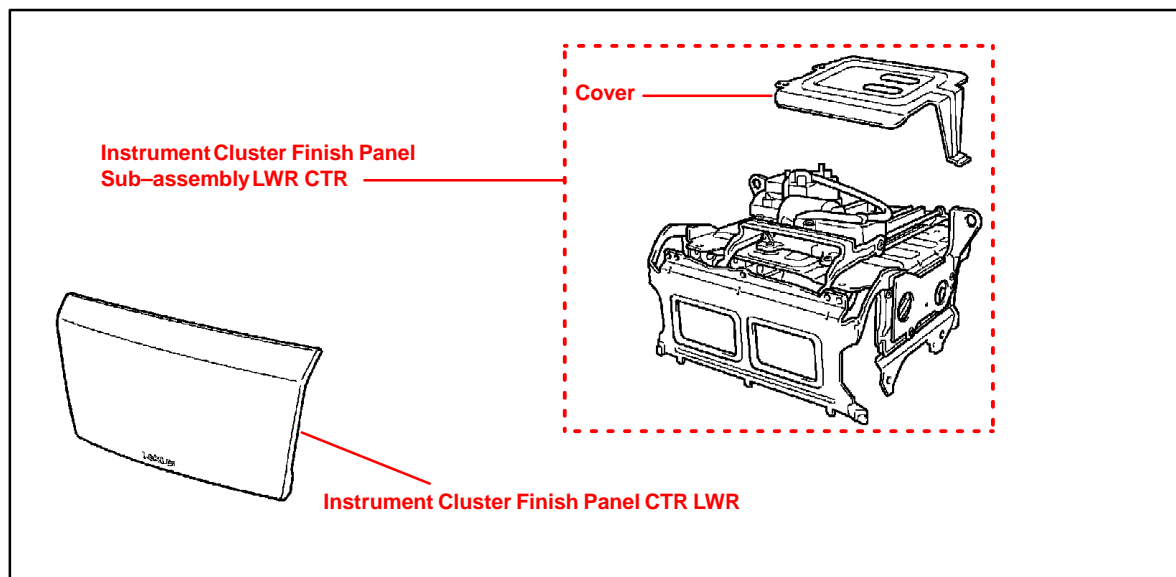
Components

Introduction To improve the opening and closing effort of the audio door, the following repair procedures have been developed.

PREVIOUS PART NUMBER	CURRENT PART NUMBER	PART NAME	QTY
N/A	55406-24040	Panel Sub-assembly, Instrument Cluster Finish, LWR CTR	1
