Subject: Safety Campaign (Special Service Campaign) - 9LG
Certain 2007 - 2010 Model Year ES 350 Vehicles
Potential Floor Mat Interference with Accelerator Pedal

I. OPERATION FLOWCHART

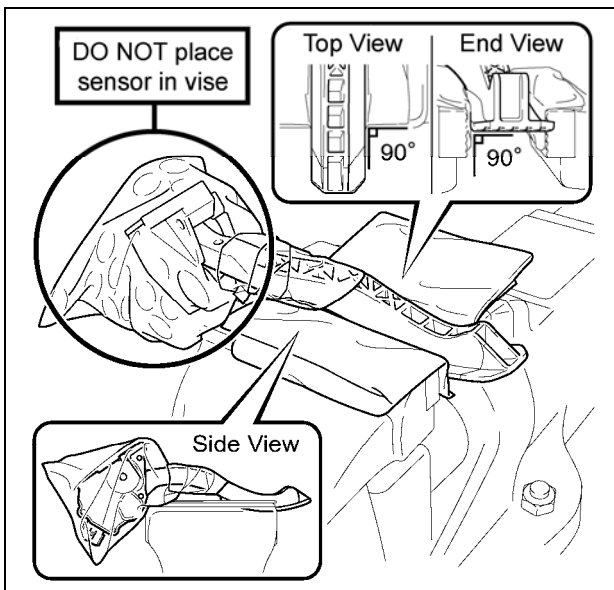
4. SECURE THE ACCELERATOR PEDAL ASSEMBLY

- a) Set the pedal in the vise at a right angle using a shop cloth while avoiding the sensor.

- **DO NOT** place the sensor in the vise to avoid damage.
- **Firmly secure the pedal to prevent it from moving.**
- **DO NOT** over tighten the vise.

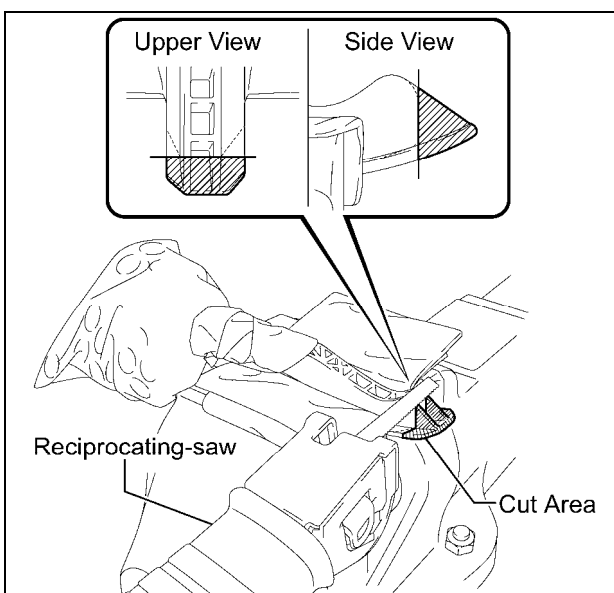
5. CUT THE ACCELERATOR PEDAL

- **Always wear protective eyewear, gloves, and dusk mask when cutting.**
- **The cut must be straight and clean.**
- **Apply consistent pressure during cutting.**
- **Do not stop while cutting.**

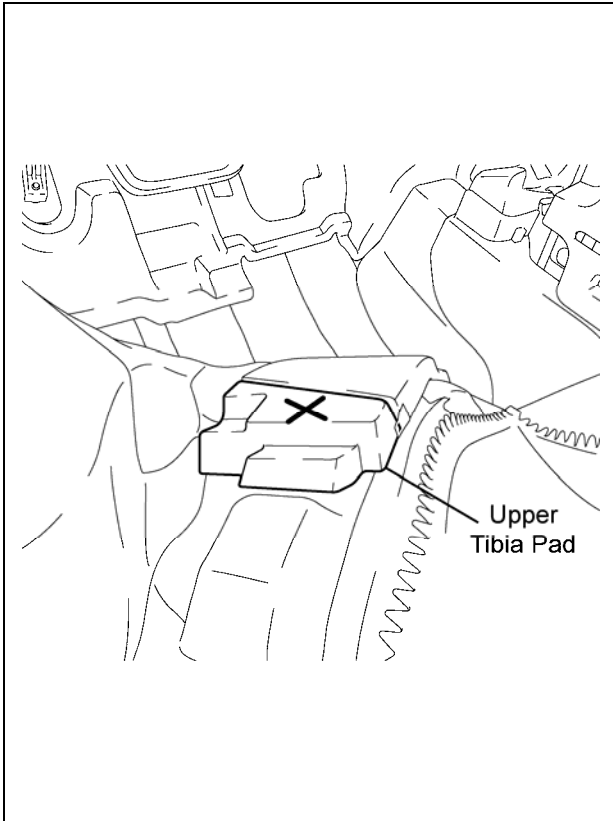
4. REMOVE THE UPPER TIBIA PAD

- a) Place an "X" mark on the upper tibia pad before removing. This will prevent them from being mixed up with the new pads.
- b) Using a ball point pen, outline the location of the upper and lower tibia pads on the carpet for positioning reference.
- c) Using a hair dryer or a low temperature heat gun, warm up the backside of the upper tibia pad until the adhesive is loose. This will make it easier to remove the upper tibia pad from the carpet. **Pay close attention when using the hair dryer or low temperature heat gun to prevent damage to the carpet.**
- d) Remove the upper tibia pad. **CAUTION: DO NOT forcefully pull the pads.** Doing so may damage the carpet. If necessary, re-heat the carpet to make the adhesive more pliable.

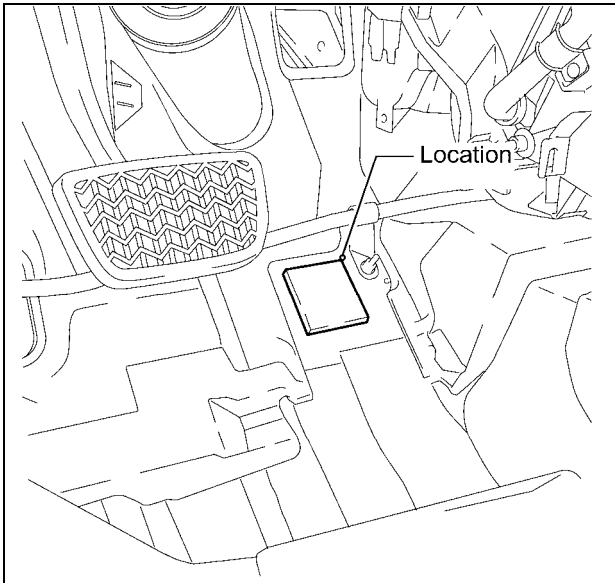
- c) Peel the double sided tape cover off the **NEW** rubber pad.
- d) Apply the rubber pad to the floor pan. The upper right corner of the rubber pad needs to be positioned next to the locating protrusion.

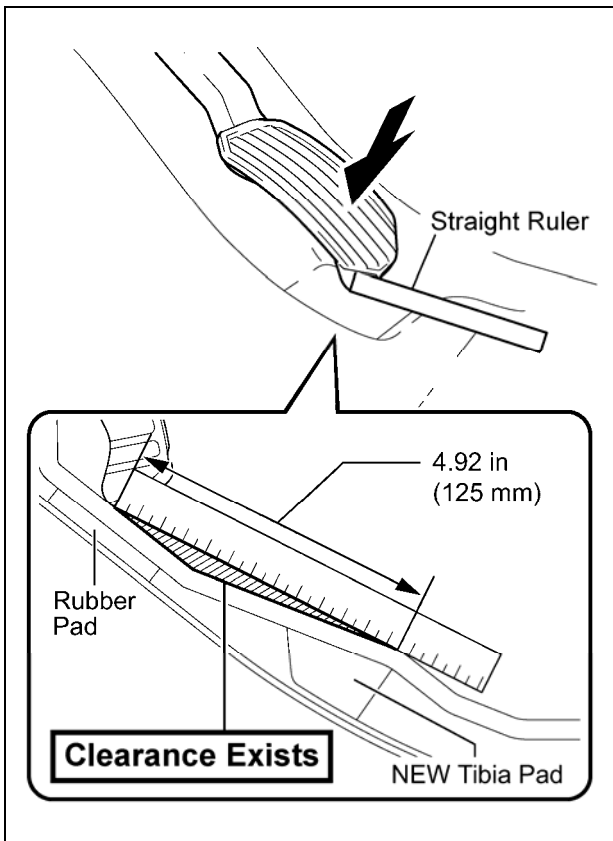
2. INSPECT THE FLOOR CARPET

- With the accelerator pedal fully depressed, confirm clearance exists between the floor carpet and the straight ruler as shown.
- If no clearance exists, reshape the carpet again.
- Confirm the claw and all fasteners of the floor carpet are securely attached.

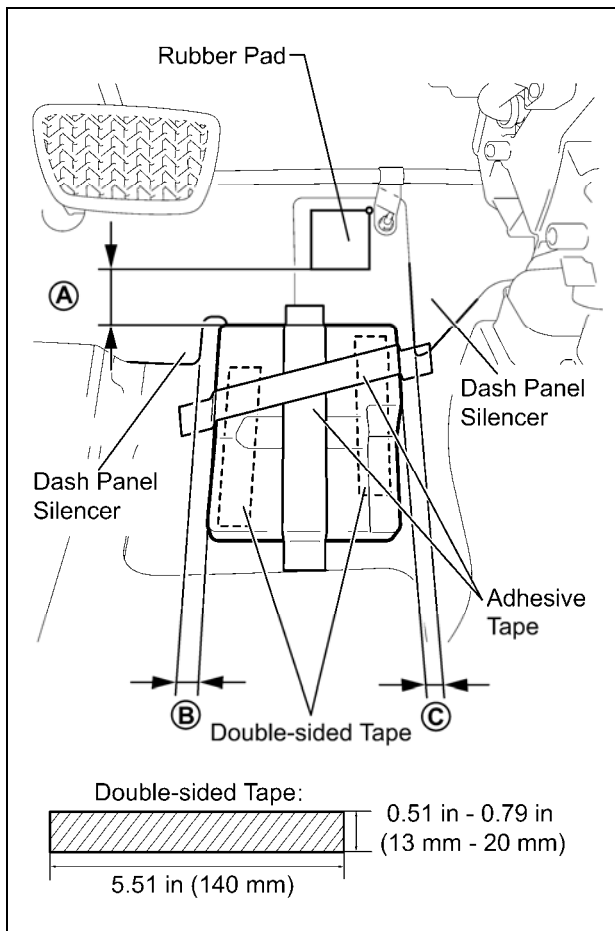
B. RELOCATING DETACHED TIBIA PADS

1. In the event the lower tibia pad has detached from the carpet following the steps below.
 - a) Apply double sided tape to the bottom (floor pan side) of the tibia pads as illustrated.
 - b) Position the tibia pads on the floor pan as indicated using the rubber pad and chart below as a guide.
 - c) Apply a piece of industrial adhesive tape from the top to the bottom of the tibia pads.
 - d) Apply a second piece of industrial adhesive tape from the left to the right side of the tibia pads.

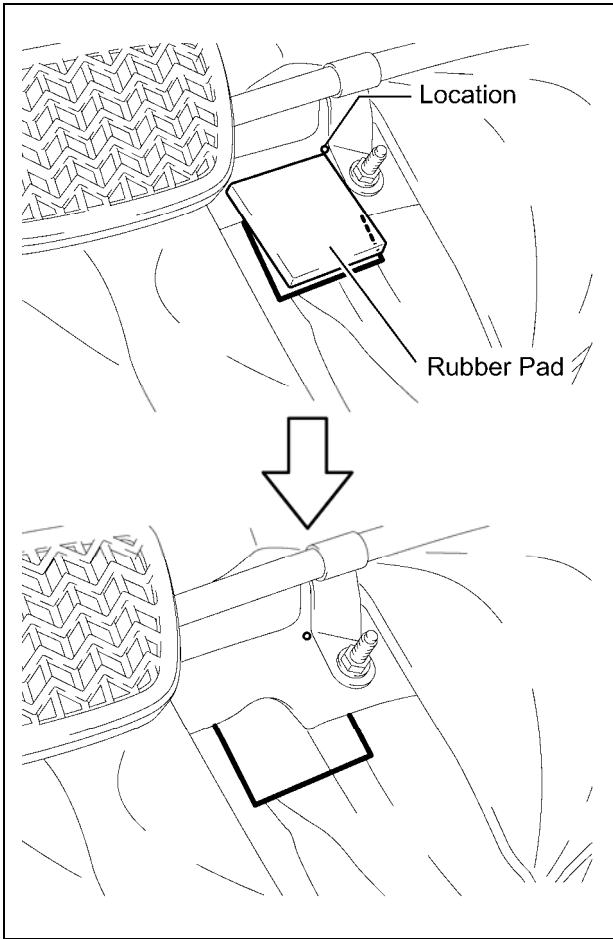
1. Temporarily place the rubber pad on the floor panel as shown, and outline the pad on the sound deadening material with a ball point pen.

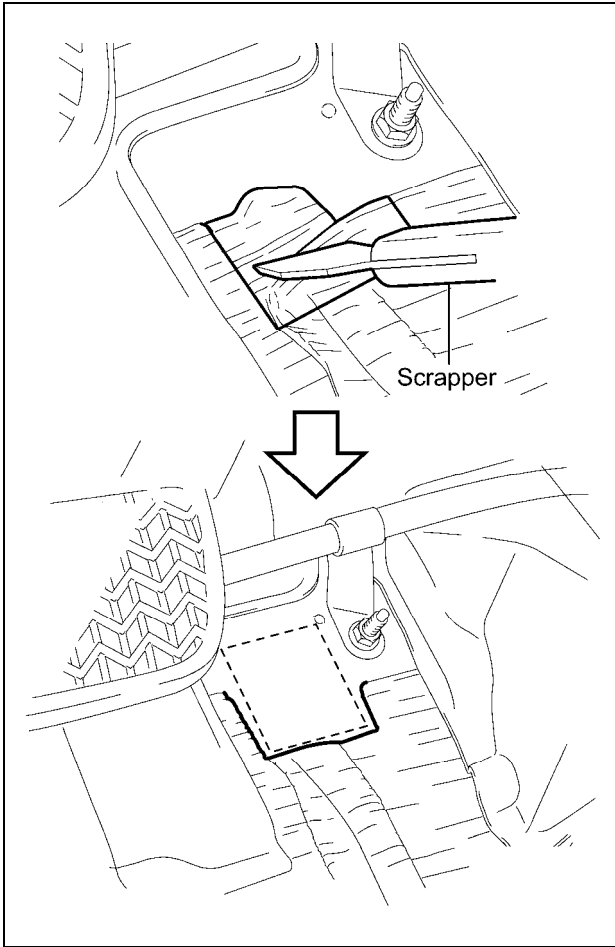
3. Using a scraper, remove the sound deadening material from the rubber pad application area.
4. Remove any loose sound deadening material from the rubber pad application area.

- **Wear protective gloves during the scraping process.**
- **Warm up the sound deadening material again, if it becomes hard during removal.**
- **Remove the sound deadening material until the rubber pad application surface is smooth.**
- **Make sure not to damage the paint film on the floor panel when scraping.**
- **Apply touch up paint if the paint film was damaged.**
