Last Modified: 7-13-2007		1.6 G
Service Category: Brake	Section: Brake (front)	
Model Year: 2008	Model: ES350	Doc ID: RM0000022JN001X
Title: BRAKE: FRONT BRAKE: INSPECTION (2008 ES350)

## INSPECTION

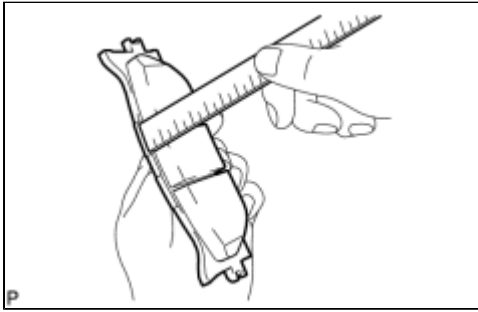
### 1. INSPECT PAD LINING THICKNESS

- (a) Using a ruler, measure the pad lining thickness.

Standard thickness:

12.0 mm (0.472 in.)

**Minimum thickness**

1.0 mm (0.039 in.)

If the pad lining thickness is less than the minimum, replace the brake pads.

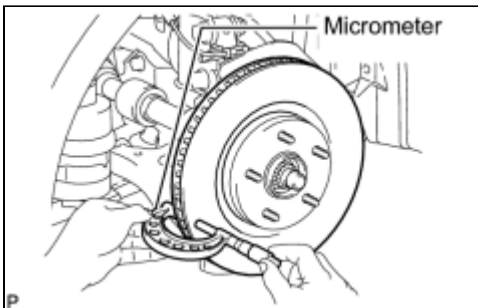
### 2. INSPECT DISC THICKNESS

- (a) Using a micrometer, measure the disc thickness.

Standard thickness:

28.0 mm (1.102 in.)

**Minimum thickness**

25.0 mm (0.983 in.)

If the disc thickness is less than the minimum, replace the front disc.

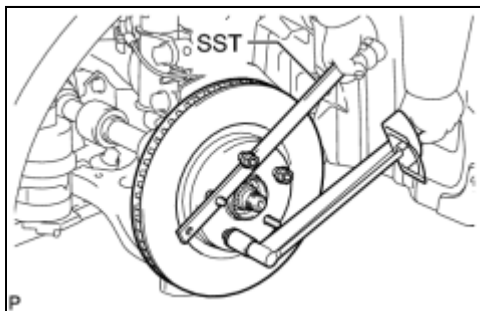
### 5. INSPECT DISC RUNOUT

- (a) Using SST to hold the disc, tighten the disc with the 3 hub nuts.

SST: 09330-00021

Torque: 103 N·m (1,050 kgf·cm, 76 ft·lbf)

**HINT:**

Use the SST to hold the disc while tightening the nuts.

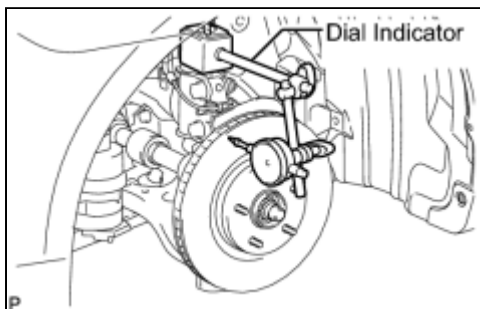
(b) Using a dial indicator, measure the disc runout 10 mm (0.39 in.) away from the outer edge of the front disc.

Maximum disc runout:

(c) If the runout exceeds the maximum value, change the installation positions of the disc and axle so that the runout will become minimal. If the runout exceeds the maximum even after the installation positions are changed, check the bearing play in the axial direction and the axle hub runout INFO. If the bearing play and the axle hub runout are normal and if the disc thickness is not within the specified range, grind the disc. If the disc thickness is less than the minimum, replace the disc.
