Last Modified: 7-13-2007		1.6 J
Service Category: Engine/Hybrid System		Section: Engine Control
Model Year: 2008	Model: ES350	Doc ID: RM000001MTC01IX
Title: 2GR-FE ENGINE CONTROL SYSTEM: SFI SYSTEM: VC Output Circuit (2008 ES350)

VC Output Circuit

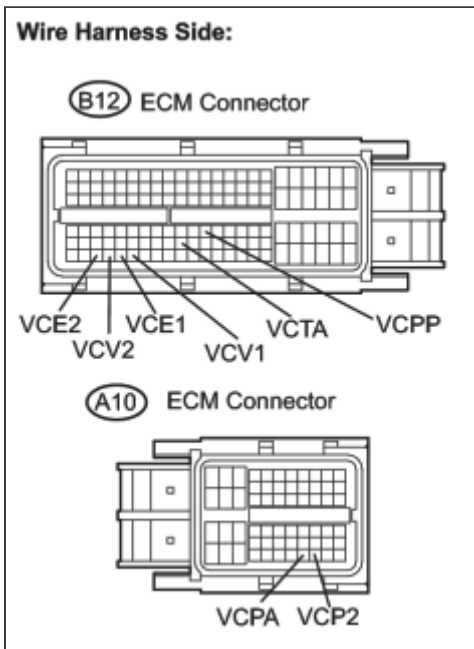
10. CHECK HARNESS AND CONNECTOR

- (a) Disconnect the throttle body connector.

- (b) Disconnect the accelerator pedal position sensor connector.
- (c) Disconnect the VVT sensor for intake camshaft bank 1 connector.
- (d) Disconnect the VVT sensor for exhaust camshaft bank 1 connector.
- (e) Disconnect the VVT sensor for intake camshaft bank 2 connector.

TESTER CONNECTION	SPECIFIED CONDITION
VCTA (B12-96) - Body ground	10 k Ω or higher
VCV1 (B12-115) - Body ground	10 k Ω or higher
VCV2 (B12-113) - Body ground	10 k Ω or higher
VCE1 (B12-114) - Body ground	10 k Ω or higher
VCE2 (B12-112) - Body ground	10 k Ω or higher
VCPA (A10-57) - Body ground	10 k Ω or higher
VCP2 (A10-58) - Body ground	10 k Ω or higher
VCPP (B12-75) - Body ground	10 k Ω or higher
