Multimedia System Enhancements Phase 3 (Pioneer)

Service Category Audio/Visual/Telematics

Section Audio/Video

Multimedia Software Update

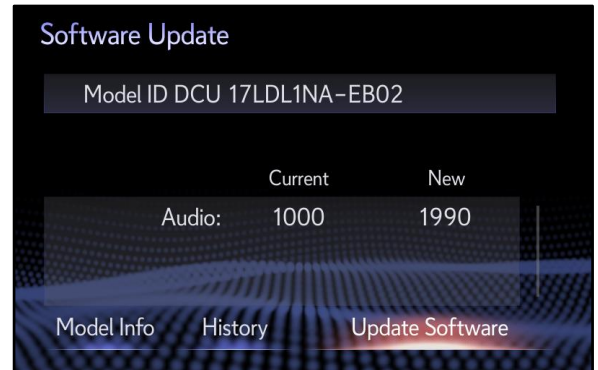
Figure 4.

8. Select the Update Software button in the lower right-hand corner.

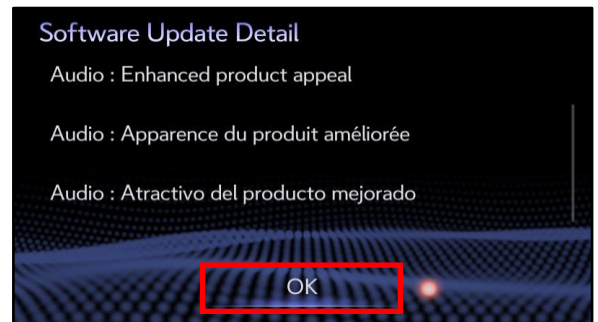
Figure 5.

9. Select OK on the Software Update Detail screen.

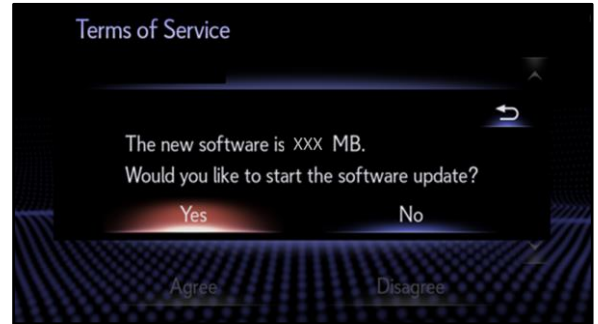
Figure 7.

11. Select Yes on the “Would you like to start the software update?” pop-up.

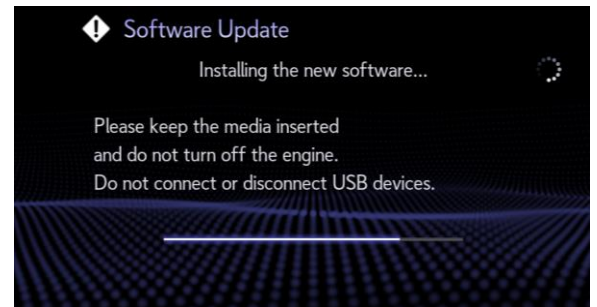
Figure 8.

12. Once the head unit begins installation, the update will take approximately 15 minutes.

- Do NOT turn off the ignition or ACC before the software is ready for updating.
- Do NOT remove the USB flash drive until instructed.

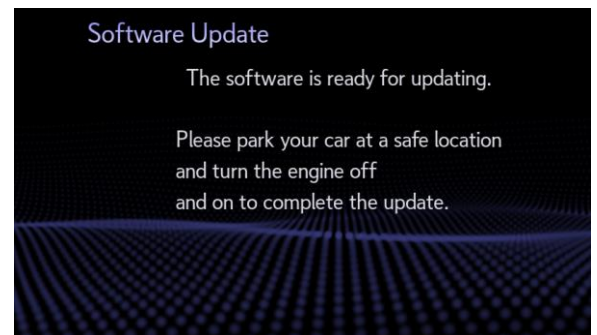
Figure 9.

13. When the “The software is ready for updating” screen appears, turn the ignition OFF.

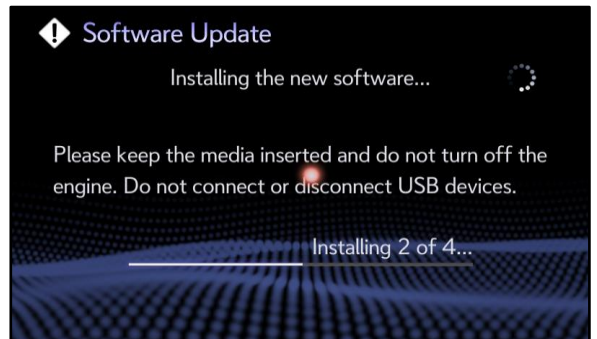
Figure 11.

17. The head unit will begin the second software installation phase.

- Do NOT turn the ignition off or ACC before the software is ready for updating.
- Do NOT remove the USB flash drive until instructed.

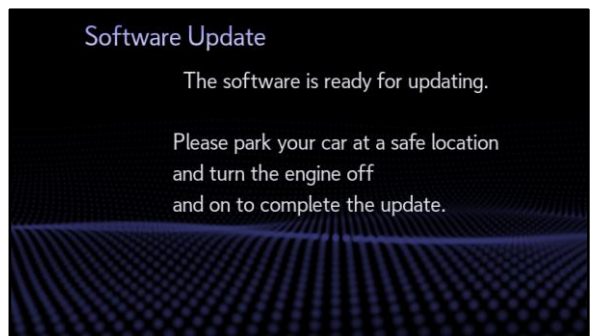
Figure 12.

18. When "The software is ready for updating" screen appears, the radio will automatically be rebooted.
