Techstream ECU Flash Reprogramming Procedure

Service Category Engine/Hybrid System

Section Emission Control

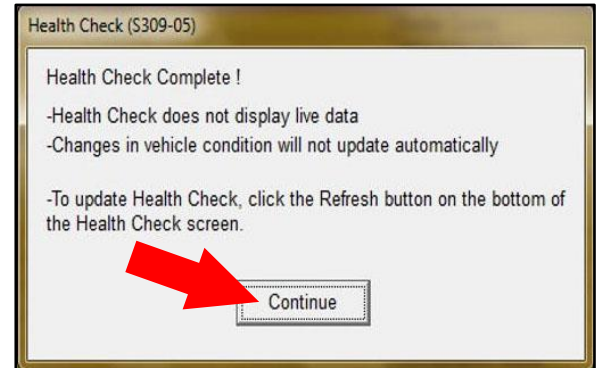
Figure 4.

- D. Click *Continue* to view the Health Check results.

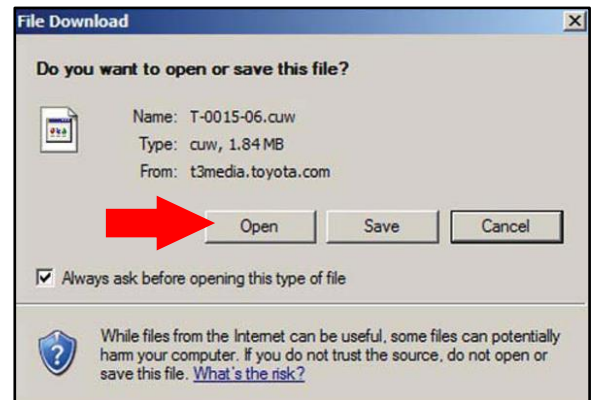
Figure 9.

- B. Click *Open* to load the calibration file information.

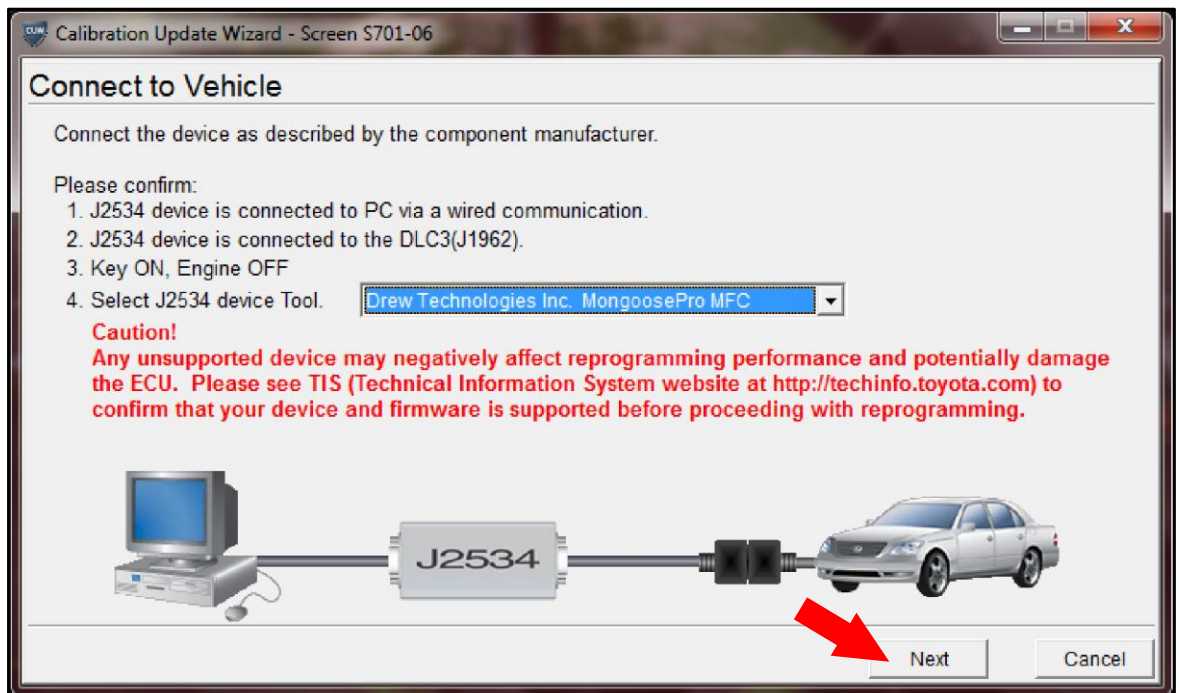
D. Confirm the following:

- PC is connected to VIM.
- VIM is connected to DLC3 connector.
- Ignition is ON and engine is OFF or Ready OFF (hybrid vehicles).

Then click *Next*.

Figure 11. Using Techstream 2.0 or Techstream Lite

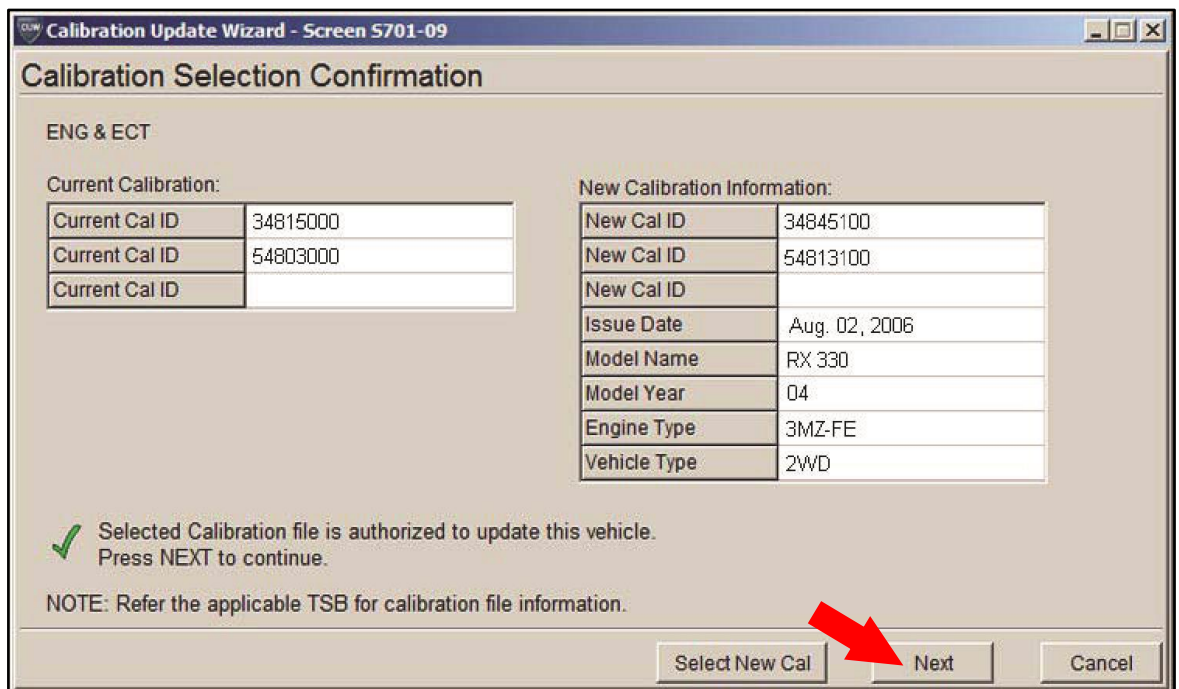
Figure 12.

Calibration Update Wizard - Screen S701-09

Calibration Selection Confirmation

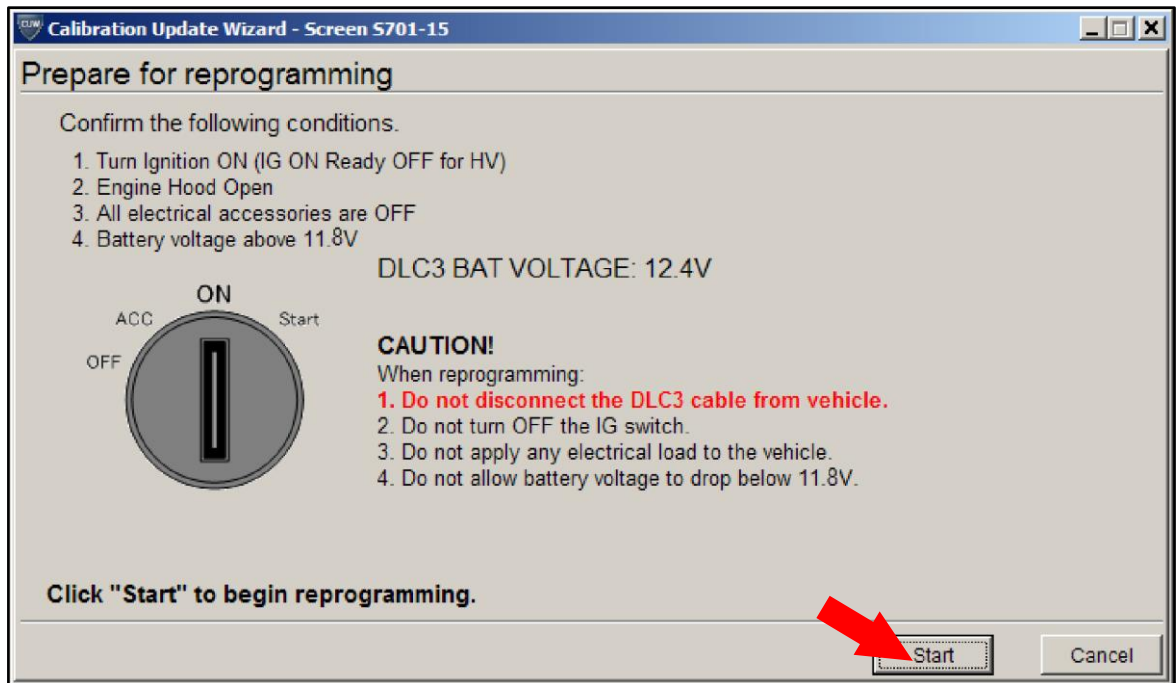
Figure 14.

Verify the vehicle is connected to a battery charger BEFORE continuing. If battery voltage falls below 11.8V, ECU damage may occur.

Then click *Start*.

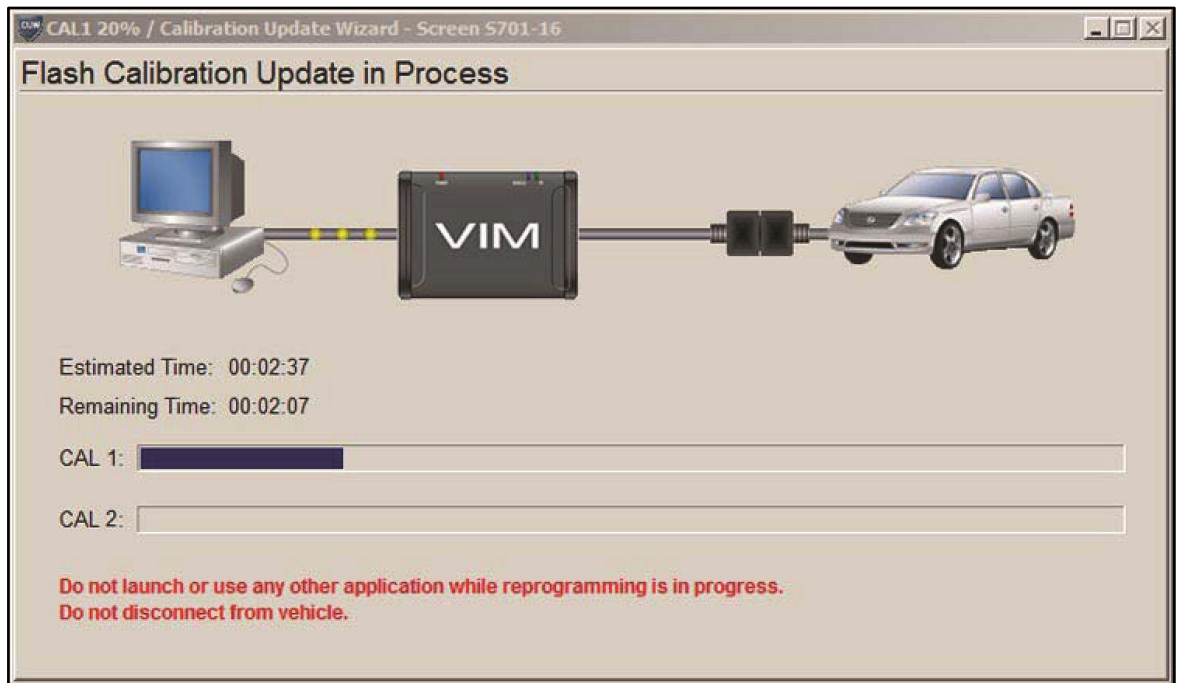
Figure 15.

- ECU flash reprogramming may take anywhere from 3 – 30 minutes per calibration file.
- Reprogramming time will vary depending on model and ECU communication protocol. Vehicles using CAN communication protocol will reprogram much faster (2 – 7 minutes).

- The total number of calibration IDs in the calibration file corresponds to the number of reprogrammable processors in the ECU.
- Each calibration file may contain up to three separate calibrations.
- Figure 15 shows an example of the update procedure for a two-processor ECU.

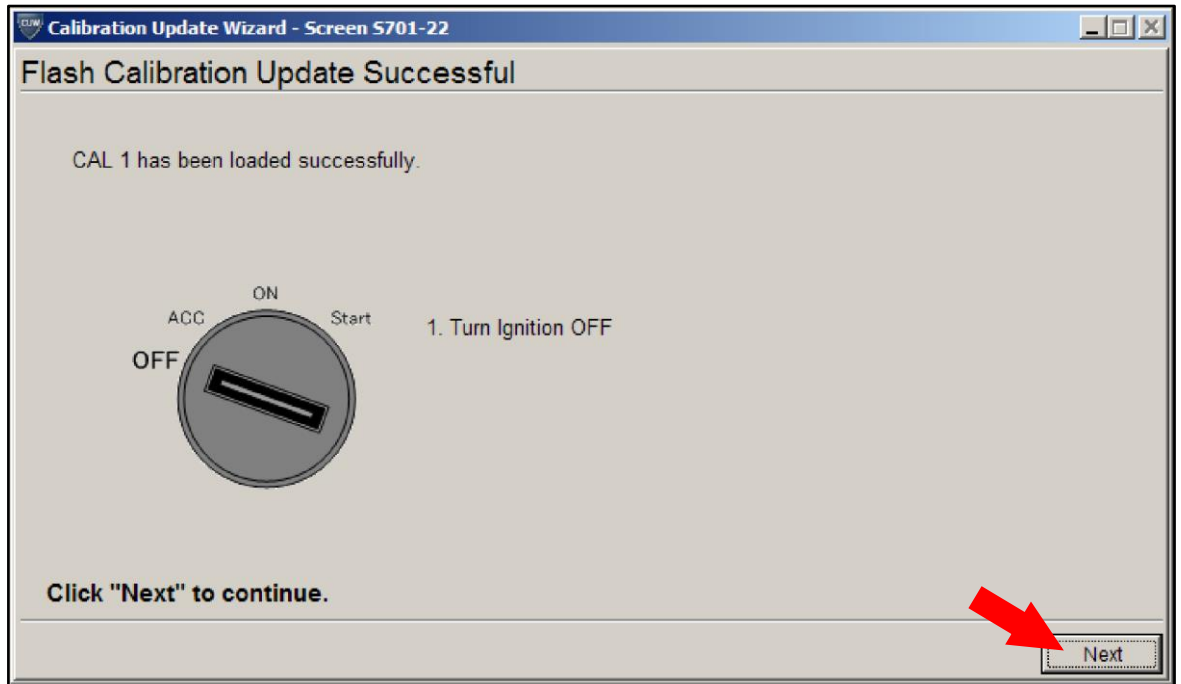
Figure 16.

- I. When Cal 1 has completed the update process, turn the ignition OFF for a minimum of 10 seconds. Then click *Next*.

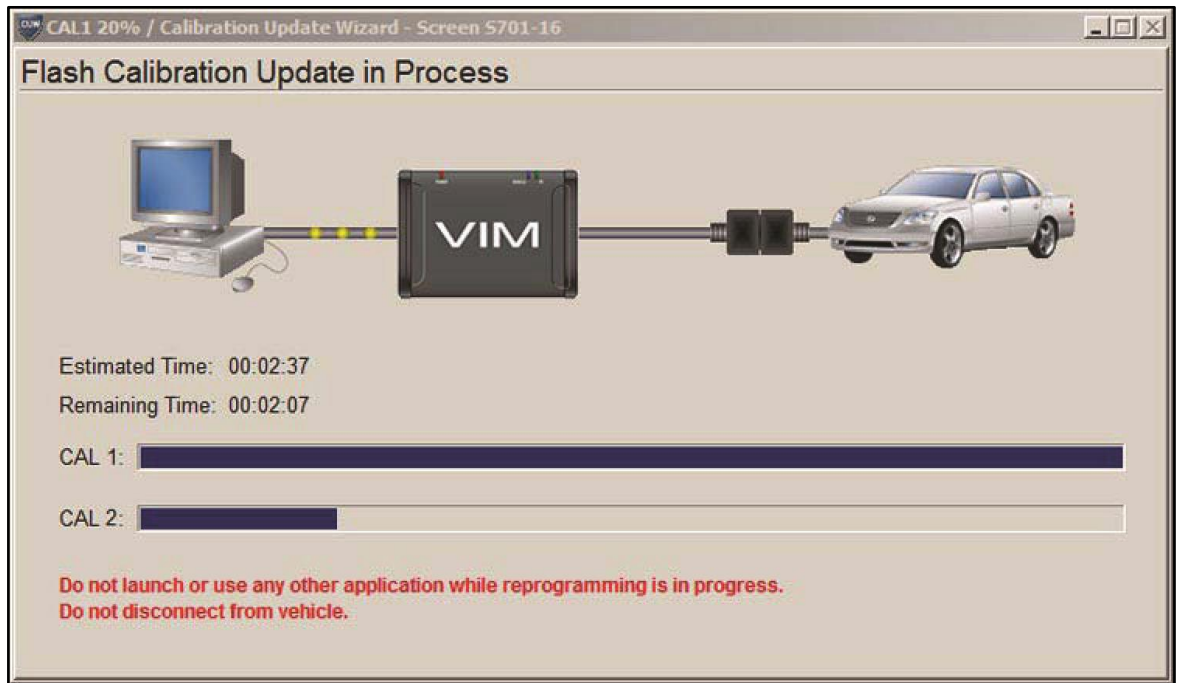
Figure 18.

- K. Do NOT disturb the vehicle during flash reprogramming.

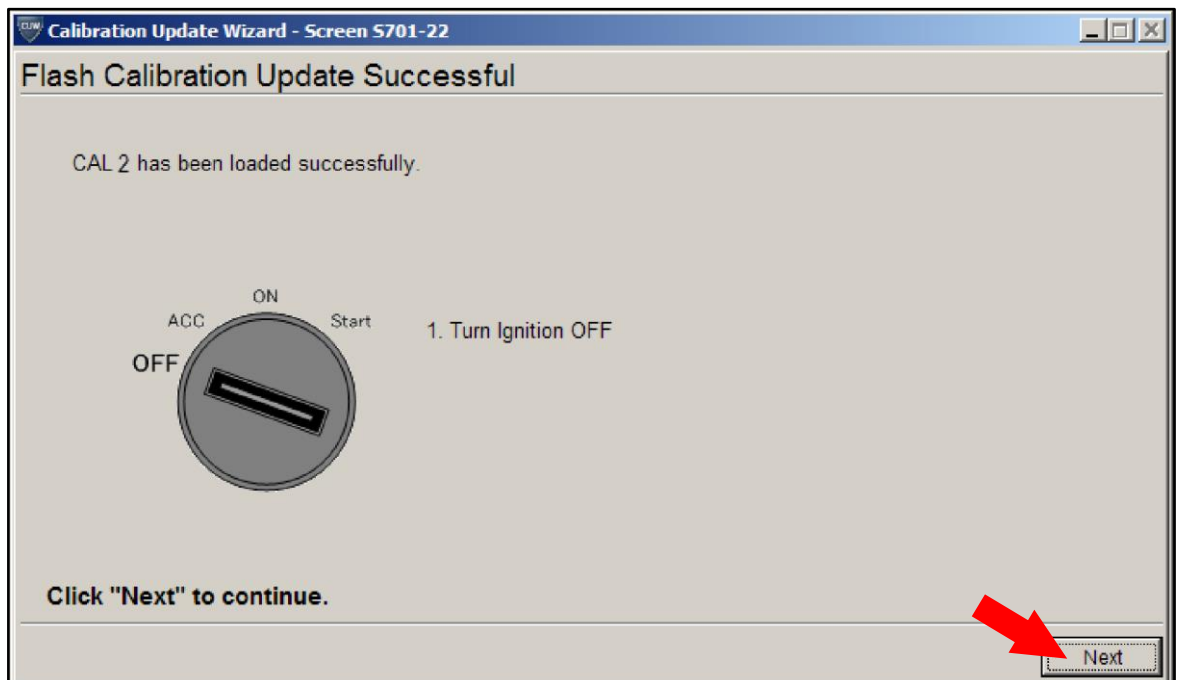
Figure 19.

- L. Turn the ignition OFF for a minimum of 10 seconds. Then click *Next*.

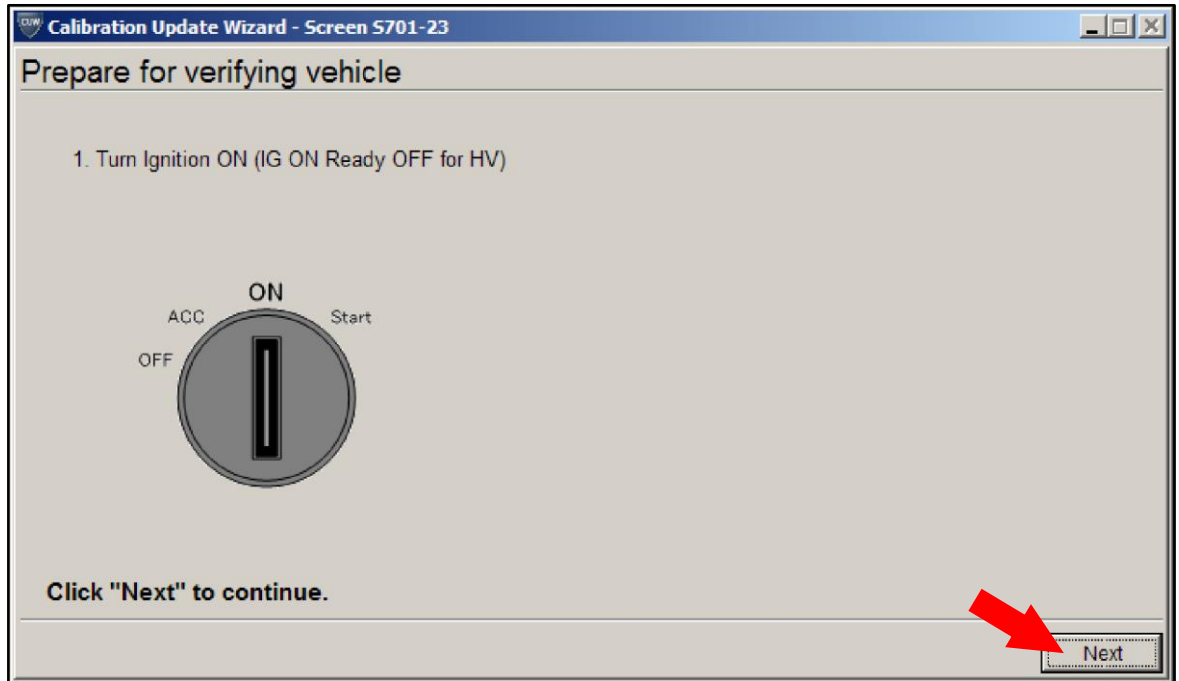
Figure 20.

- M. Turn the ignition to the ON position. Then click *Next*.
