HVAC Evaporator Drain Hose Clogged Due to Insect Intrusion

Service Category Vehicle Interior

Section Heating/Air Conditioning

Introduction

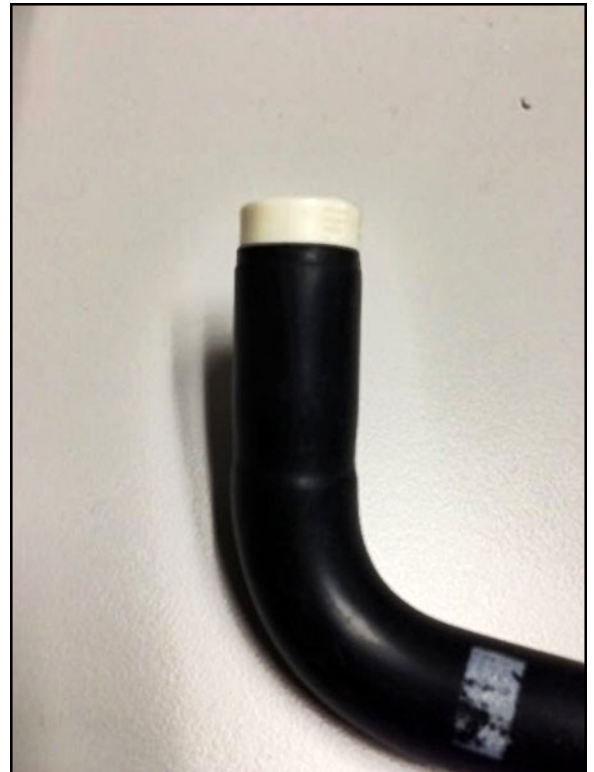
1. Follow the instructions provided in the Safety Requirements for Handling the ARINIX® Tip (Connector, Water Hose) section of this bulletin.
2. Locate the HVAC Evaporator Drain Hose.
3. Following the vehicle specific Repair Manual, remove the HVAC Evaporator Drain Hose.
4. Put on all necessary PPE and install the ARINIX® Tip (Connector, Water Hose) into the NEW HVAC Evaporator Drain Hose listed in the Parts Information section of this bulletin.
5. When installing the ARINIX® Tip, verify it is fully seated in the HVAC Evaporator Drain Hose as shown in Figure 1.
6. Following the vehicle specific Repair Manual, install the HVAC Evaporator Drain Hose.

1. Follow the instructions provided in the Safety Requirements for Handling the ARINIX® Tip (Connector, Water Hose) section of this bulletin.
2. Locate the HVAC Evaporator Drain Hose.
3. Following the vehicle specific Repair Manual, remove the HVAC Evaporator Drain Hose.
4. Put on all necessary PPE and install the ARINIX® Tip into the original HVAC Evaporator Drain Hose listed in the Parts Information section of this bulletin.
5. When installing the ARINIX® Tip, verify it is fully seated in the HVAC Evaporator Drain Hose as shown in Figure 1.
6. Following the vehicle specific Repair Manual, install the HVAC Evaporator Drain Hose.

6. When installing the ARINIX[®] Tip, verify it is fully seated in the HVAC Evaporator Drain Hose as shown in Figure 1.
7. Following the vehicle specific Repair Manual, install the HVAC Evaporator Drain Hose.

1. Follow the instructions provided in the Safety Requirements for Handling the ARINIX[®] Tip (Connector, Water Hose) section of this bulletin.
2. Locate the HVAC Evaporator Drain Hose
3. Following the vehicle specific Repair Manual, remove the HVAC Evaporator Drain Hose.
4. Before installing the ARINIX[®] Tip (Connector, Water Hose) into the original HVAC Evaporator Drain Hose, the end of the hose needs to be cut perpendicular as shown in Figure 2.
5. Put on all necessary PPE and install the ARINIX[®] Tip into the original HVAC Evaporator Drain Hose listed in the Parts Information section of this bulletin.
6. When installing the ARINIX[®] Tip, verify it is fully seated in the HVAC Evaporator Drain Hose as shown in Figure 1.
7. Following the vehicle specific Repair Manual, install the HVAC Evaporator Drain Hose.

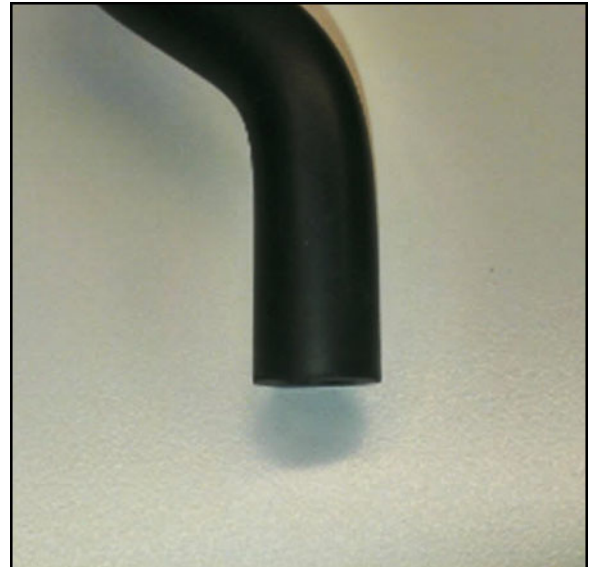
1. Follow the instructions provided in the Safety Requirements for Handling the ARINIX® Tip (Connector, Water Hose) section of this bulletin.
2. Locate the HVAC Evaporator Drain Hose.
3. Following the vehicle specific Repair Manual, remove the HVAC Evaporator Drain Hose.
4. Before installing the ARINIX® Tip (Connector, Water Hose) into the NEW HVAC Evaporator Drain Hose, the end of the hose needs to be cut perpendicular as shown in Figure 2.
