# MIL "ON" DTC P030# and/or Intermittently Runs Rough

YEAR(S)	MODEL(S)	ADDITIONAL INFORMATION
2006 – 2010	IS250

Some 2006 – 2010 model year IS 250 vehicles may exhibit one or more of the following conditions:

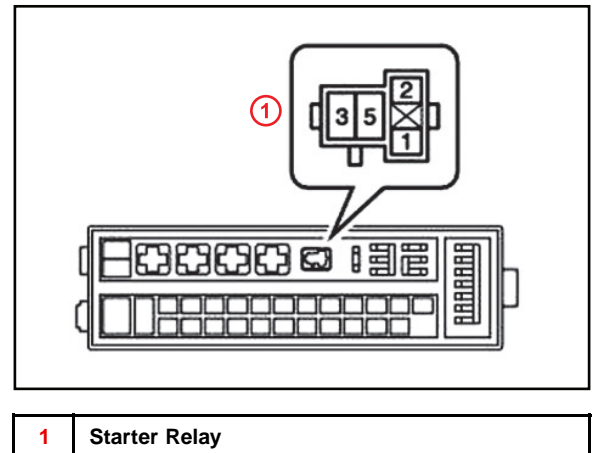
Figure 1. Engine Room No. 1 Relay Block

1. Run the engine and bring to operating temperature.
2. Remove the intake air surge tank assembly.
3. Remove all ignition coils and spark plugs.
4. Remove the starter relay.
5. Using a funnel as necessary, pour 1.0 oz of GM Upper Engine and Fuel Injector Cleaner (GM P/N 88861802) into each of the 6 cylinders via the spark plug holes.
6. Place and secure shop towels over all the spark plug tubes.
7. Crank the engine for 5 seconds using a jumper wire at the starter relay terminals 3 and 5.

Cranking will assure even dispersal of top engine cleaner on the piston domes.
