HID Headlamp Housing Paint Bubble / Poor Appearance

Service Category Vehicle Exterior

Section Lighting (ext)

Some 2011 – 2012 model year IS 250/350/250C/350C and IS F vehicles equipped with HID (High Intensity Discharge) headlights may exhibit a paint bubbling/wrinkling concern on top of the LED strip within one or both of the headlight housings. Newly designed headlight units have been developed to address this condition. Follow the procedure in this bulletin to install the updated headlight units.

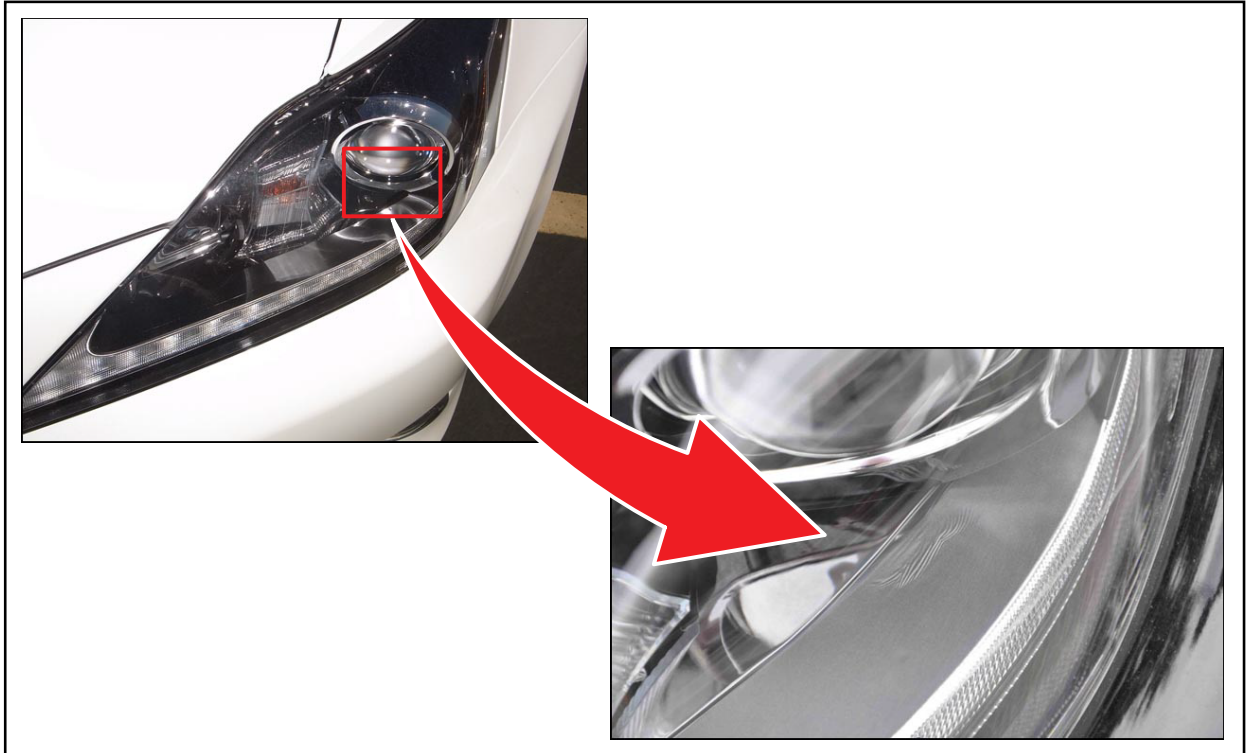
Figure 1.

1. Confirm vehicle has the headlight housing paint bubble condition (see Figure 1 for an example).
If a poor appearance is found, continue to step 2. If not, this TSIB does **NOT** apply.

2. Replace both headlight units.
