## How to replace the upper control arms on a 1991 Lexus LS400

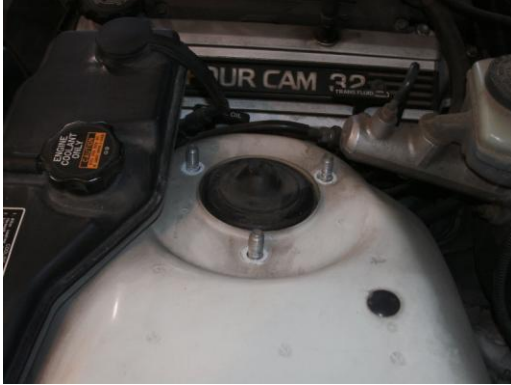
1. Raise front of car and put on jack stands
2. Remove wheels
3. Remove the three nuts on top of each strut

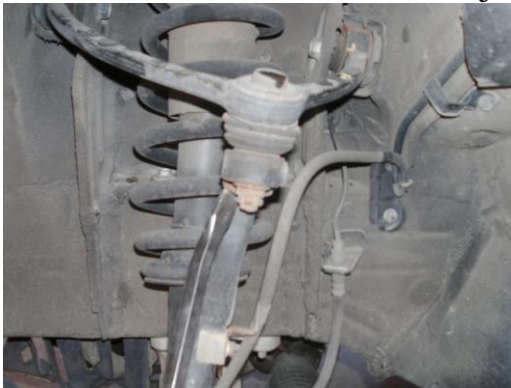
4. Remove castle nut from ball joint

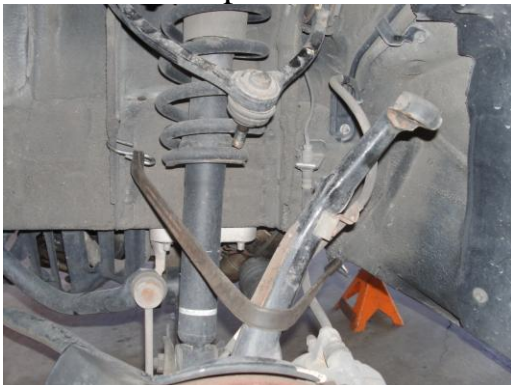
5. Remove ball joint from knuckle assembly (usually requires just a few well placed taps from a ball peen hammer. I would suggest supporting the knuckle to prevent undue stress on the brake line.

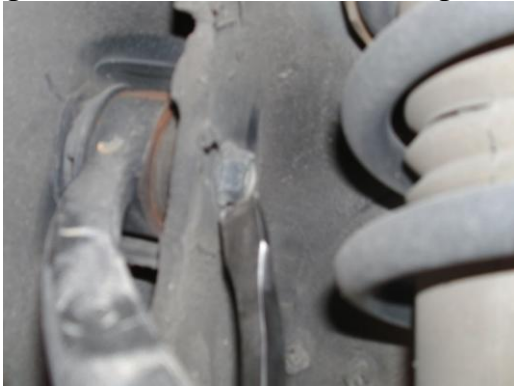
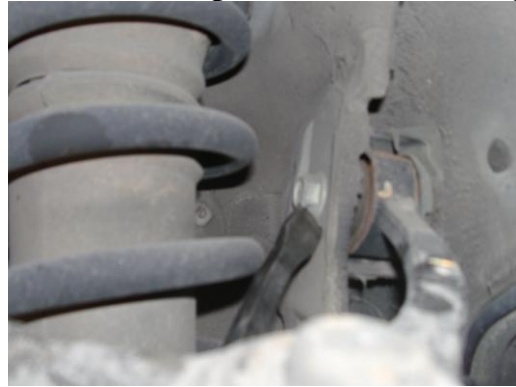
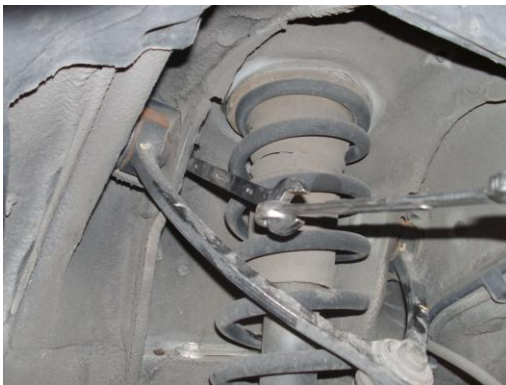
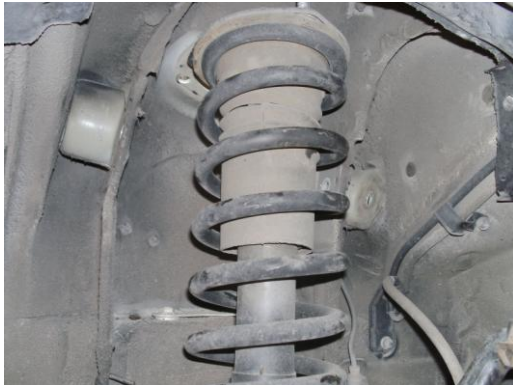
7. Remove the two bolts then remove arm assembly. They may be very tight in which case interlocking two wrenches will provide extra leverage

6. Push down on the rotor assembly to allow the top of the strut to be pulled out of the way for access to the two bushing bolts.

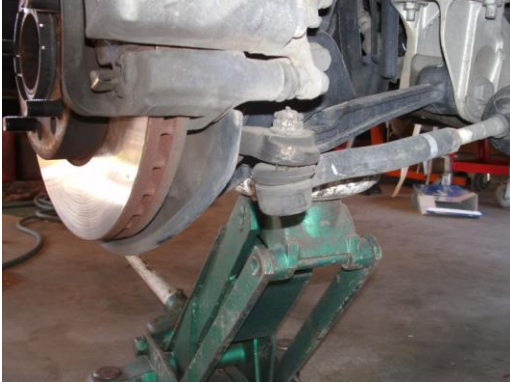
9. After everything has been reassembled and the ball joint tightened to recommended torque, place a floor jack under the lower control arm so that the full vehicle weight loads the suspension. Now you can tighten the two bolts. Failure to do this will create undue stress on the bushings and will cause premature failure.

8. Install new control arm but **DO NOT** tighten the two bushing bolts at this time.

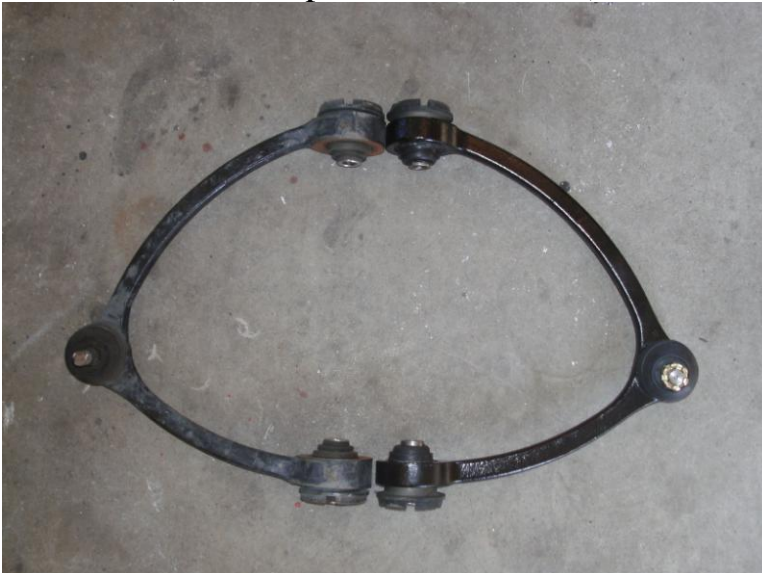
This is what the Chinese import looks like compared to the factory assembly. The bushing area is notably smaller but for the price difference (\$275.00 pair vs. \$550.00 ea) I can live with that.

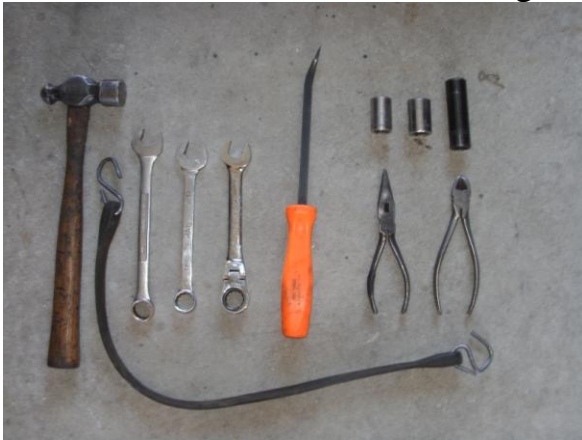
These are the tools that are needed: 17mm wrench, 14, 17 and 18mm sockets, side cutters, hammer, bungee strap and small pry bar.
