How to remove the radio head unit in a 2000 Lexus LS400.

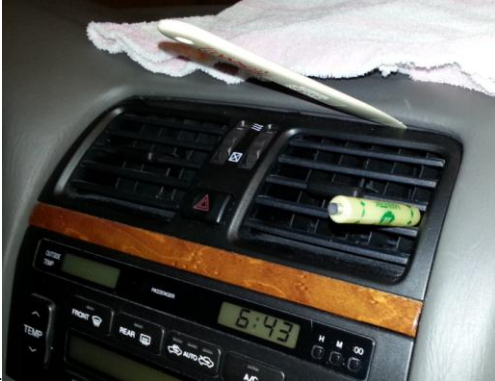
Remove the center vent assembly by pulling the spring loaded retaining clip on each side inward with a small screwdriver while gently prying the assembly out with a non-scarring trim removal tool.

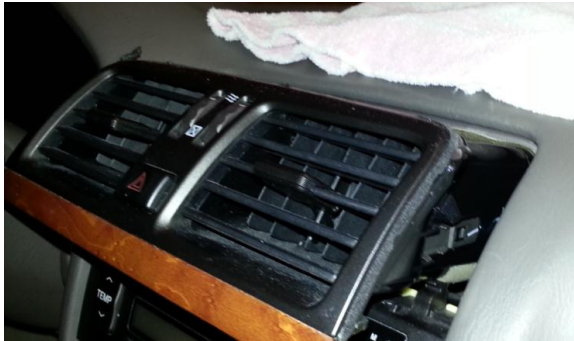
Slide the vent assembly out, move the hazard flasher connector, and set the vent assembly aside.

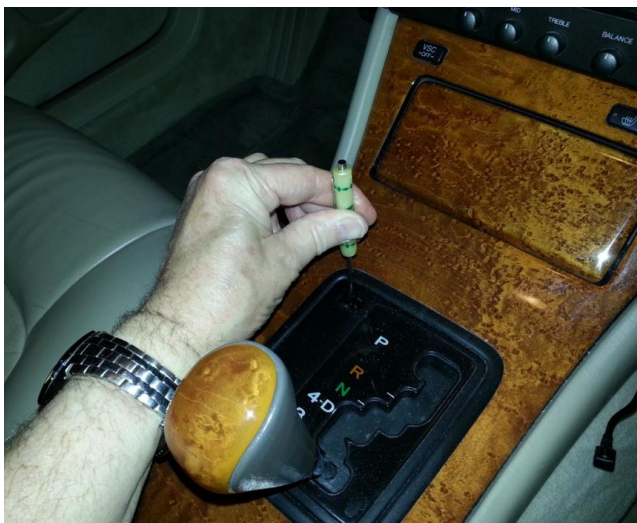
Block the car wheels to prevent the car from rolling when the gear shift is moved from Park. ALSO SET THE PARKING BRAKE. Remove the small cover for the shift interlock switch, press the interlock switch down, and pull the gear shift lever all the way rearward.

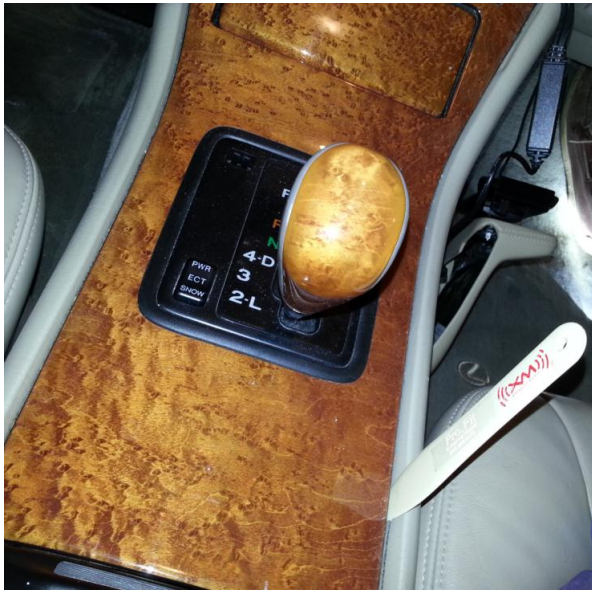
Gently but firmly pry the wood console panel out with a trim removal tool.

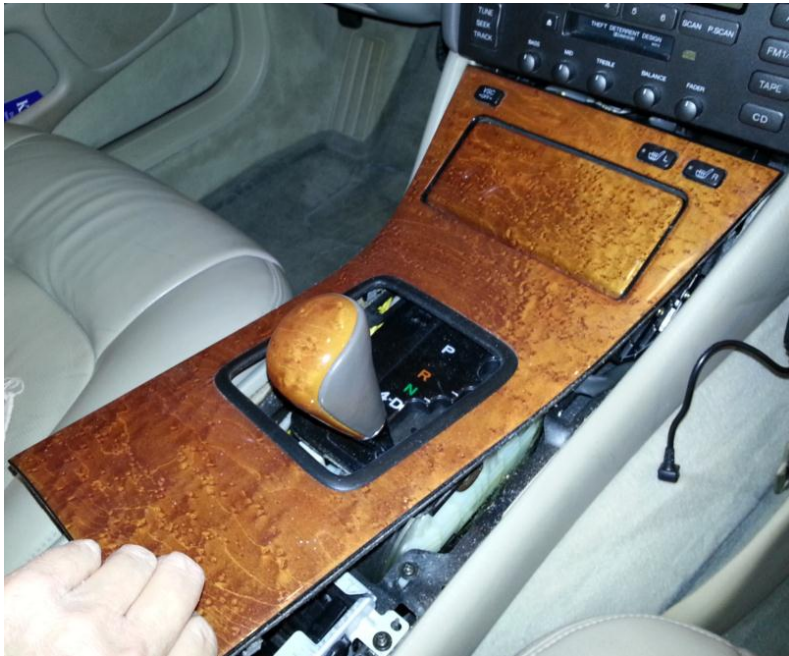
Remove the wood console panel. Disconnect the connectors for the ashtray light, VSC, seat heater switches, etc. Set the wood console panel aside.

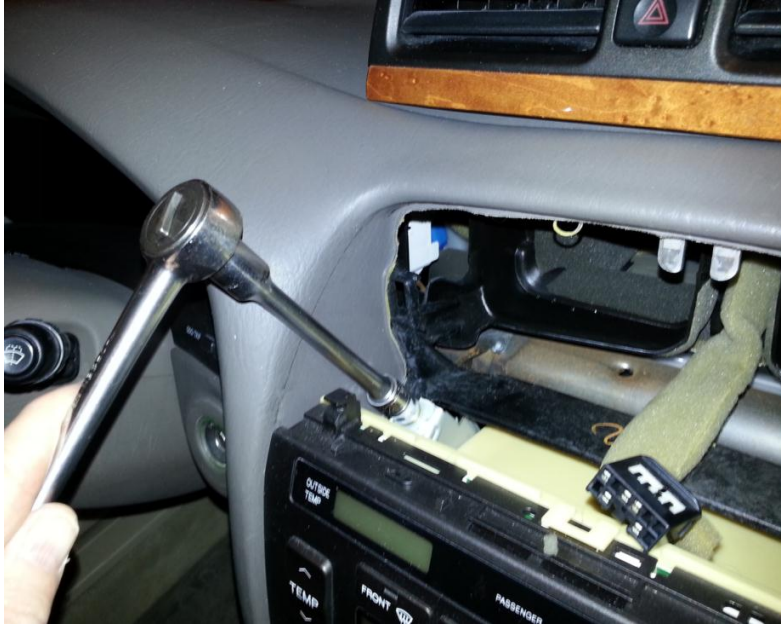
Remove the four 10mm bolts (2 top, 2 bottom) holding the radio/HVAC assembly in place.

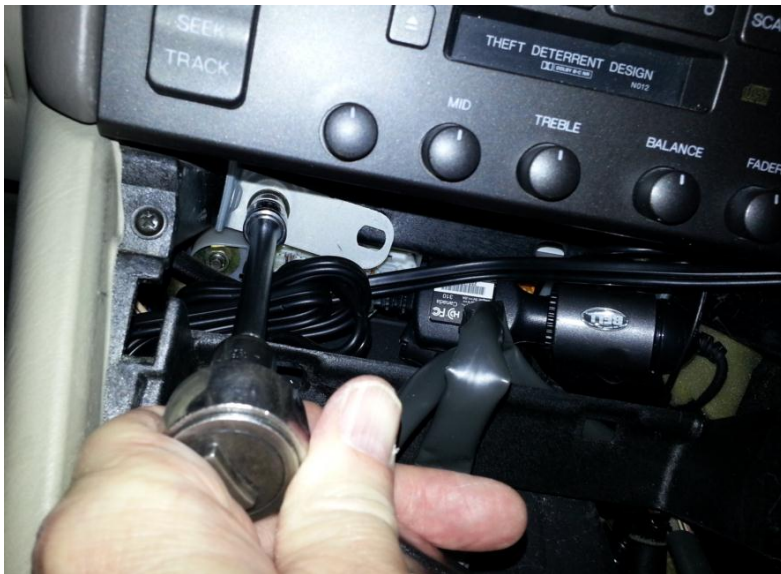
Remove the two bottom 10mm bolts holding the radio/HVAC assembly in place.

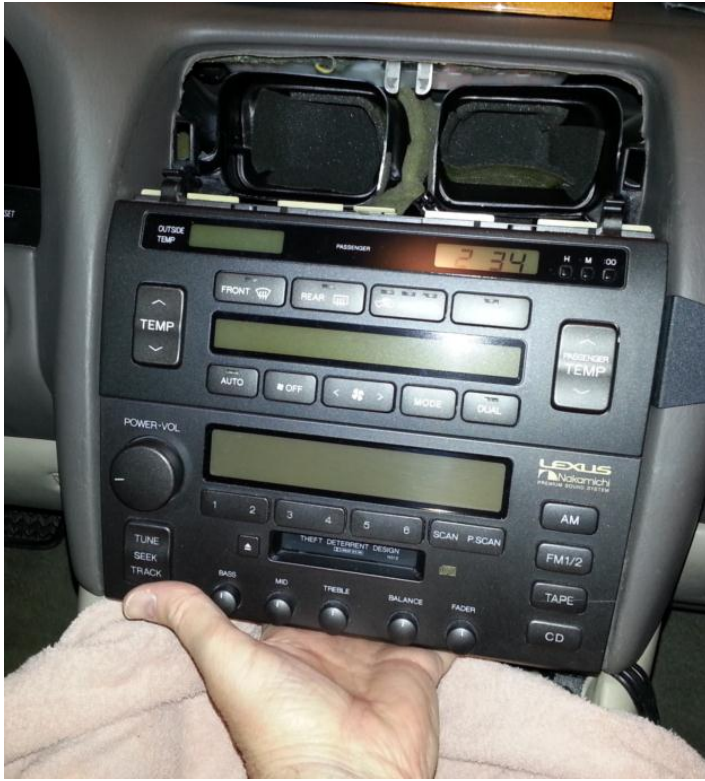
Use a towel to protect the vinyl on the console rails. Pull the radio/HVAC unit out and rest it on the towel.

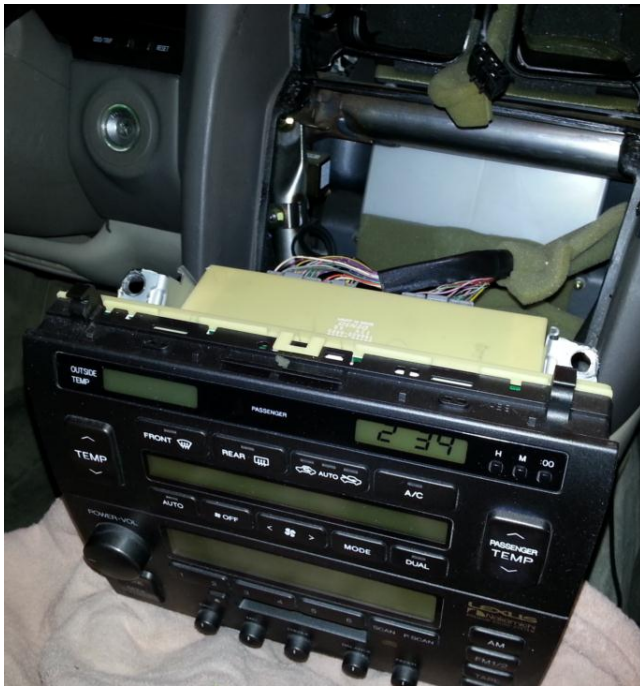
Unplug the radio and HVAC connectors from the radio/HVAC assembly.

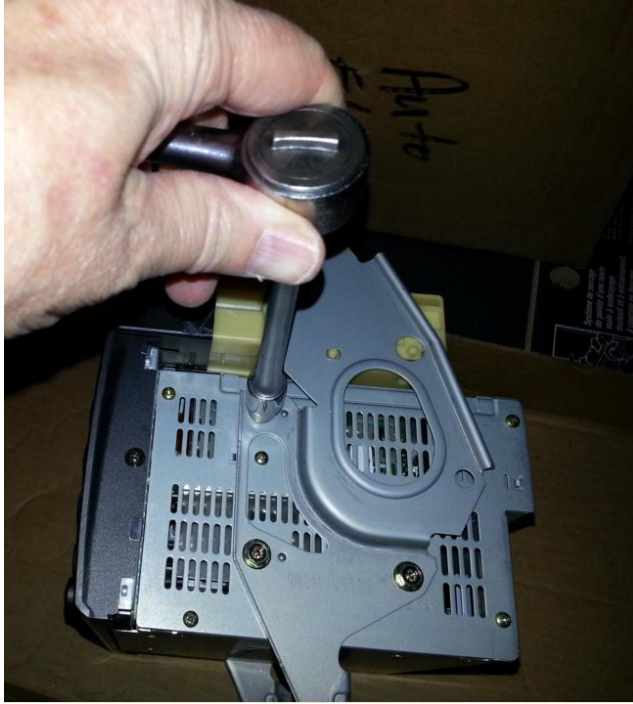
Place the radio/HVAC assembly on a workbench with a protective surface (e.g. cardboard). Remove the six screws that hold the radio head unit to the frame – three screws on each side.

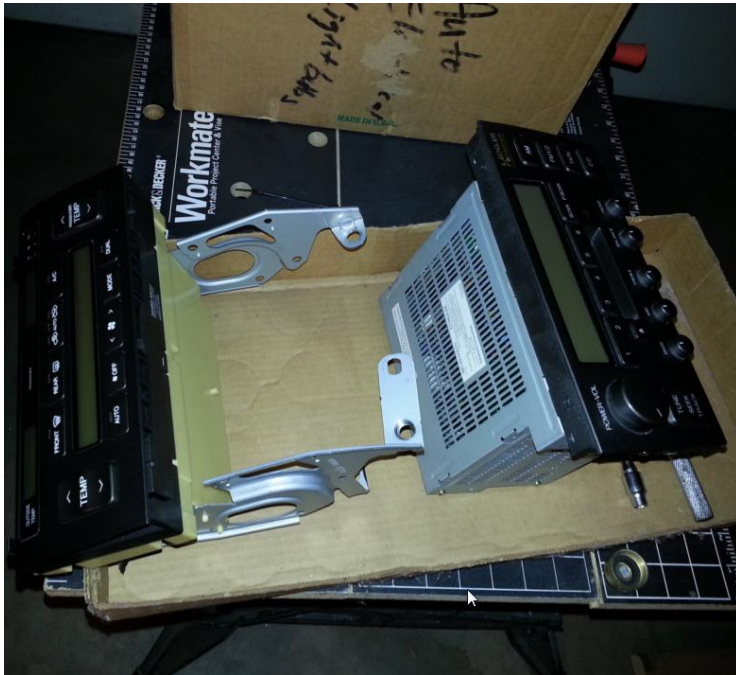
Separate the radio head unit from the frame.

Ensure that there is no or minimal gap between the HVAC assembly and radio head unit. A gap may make it difficult to reinstall the center vent assembly.
